Study on Post-Tsunami Restoration and Conservation Projects in the Maldives

Marie Saleem and Shahaama A. Sattar

Ecosystems & Livelihoods Group, Asia

This is a working paper to be finalized during a stakeholder consultative workshop scheduled from March 16-19, 2009.

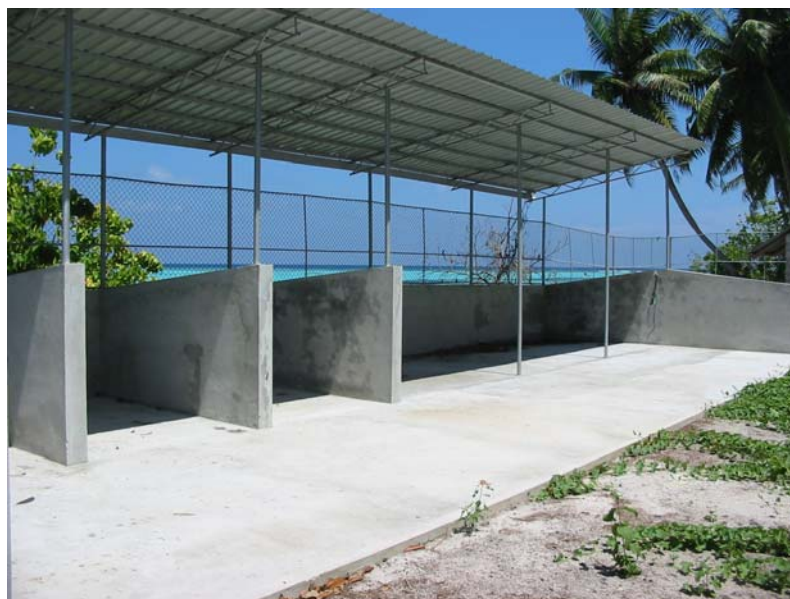
Figure 3. Waste management centre at A.Dh. Dhangethi

Seventy nine WMCs were built in 76 communities under the ARC/CRC waste management program (ARC/CRC, 2007). Island Waste Management Centres (IWMC) have the capacity to segregate and store non-biodegradable waste in 3 compartments, namely, Plastics, Metals and Residuals (Figure 3). A large area

is dedicated to composting activities of the organic waste. A locked area is also present to store hazardous waste. When the project work was completed, all WMCs were handed over to communities.

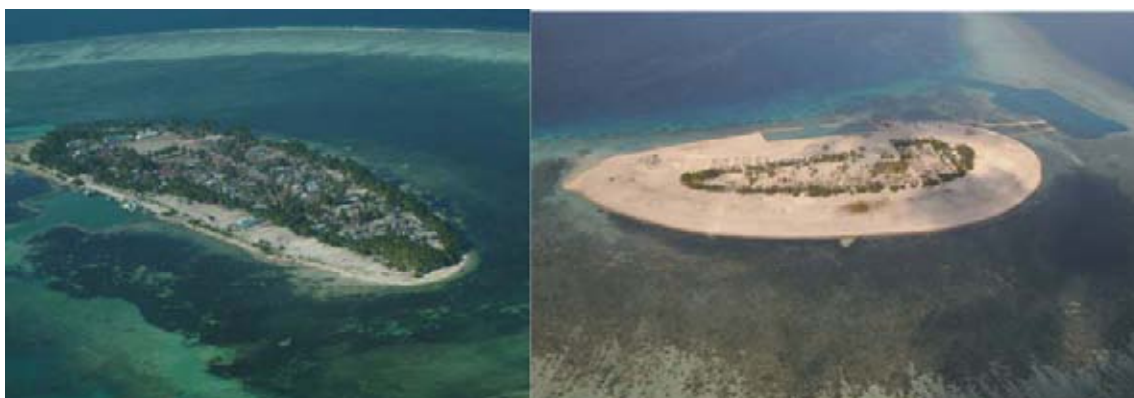
Figure 4. Vilufushi pre-tsunami (left) and after the post-tsunami reclamation (right) where the island has been reclaimed to 3 times its natural size

Even before the tsunami, Vilufushi had been chosen as one of the 20 islands to be developed under the “Safe Islands Programme’. Under this project these islands will have seawalls, vegetation enclosures surrounding the island and a drainage system to remove flood water in case of high waves. A plan was in place to reconstruct the island of Vilufushi to three times its size at the time. This was implemented and has resulted in a landmass of approximately 61 ha in contrast to the previous size of 16 ha (Figure 4). The new Vilufushi was designed to fit the same shape as the previously existing island preserving where possible its existing natural wealth.
