# Summarizing And Analyzing Restoration And Conservation Initiatives Post-Tsunami In The Indonesia Technical Report

# **Technical Report Summarizing And Analyzing Restoration And Conservation Initiatives Post-Tsunami In The Indonesia**

**By Woro Yuniati and Ben Brown**

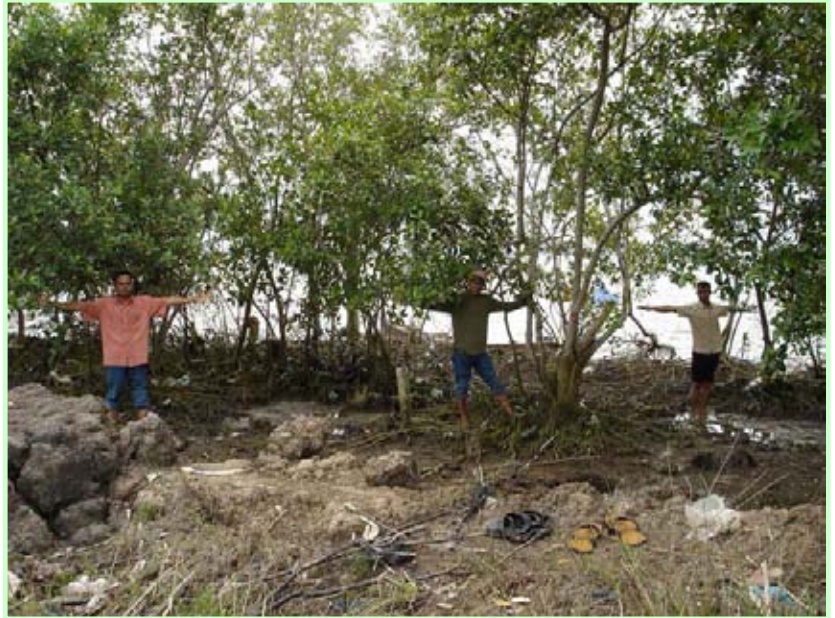
Coastal Greenbelt laws in Indonesia, even when they are on the books, are seldom enforced. Fishermen measure the width of this sparse greenbelt in North Sumatera, which hardly serves an eco-barrier to storm events (Top). Inside of this sparse Greenbelt lies a 40 hectare abandoned shrimp pond. (Bottom) Neither the Greenbelt nor the pond complex provide ecological or economic services to local communities.

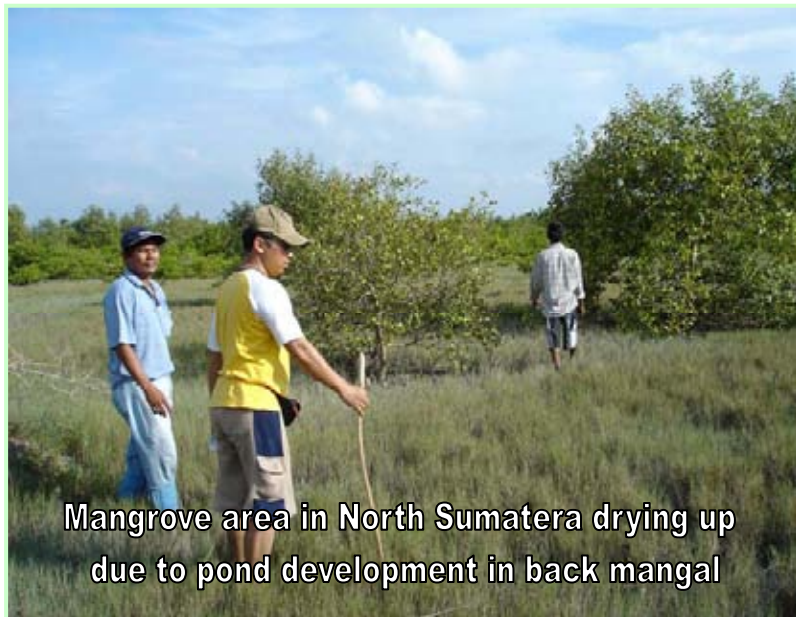
Mangrove area in North Sumatera drying up due to pond development in back mangal

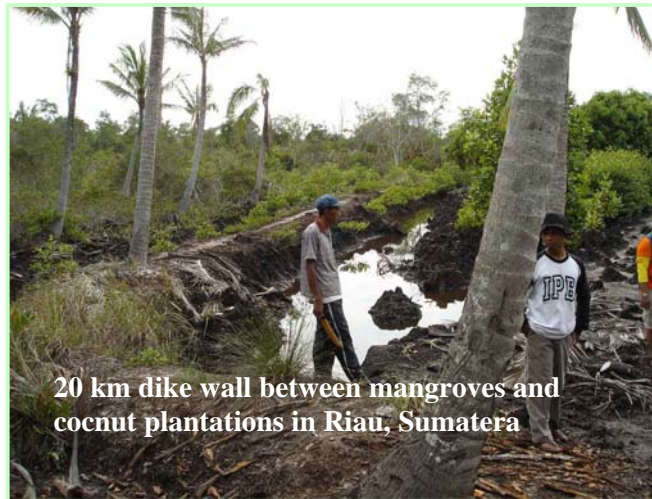
*1.2.5 Agriculture* – Oftentimes farmers build dike walls in Indonesia to “protect” crops such as rice or coconut from salt water influx. Rising sea level is causing an increase in this behavior. In reality, these dike walls block freshwater flows into mangroves, which may die-off and actually increase saltwater infiltration. Salt water easily penetrates these dike walls anyway through the ground and also through numerous crab holes.

20 km dike wall between mangroves and coconut plantations in Riau, Sumatera

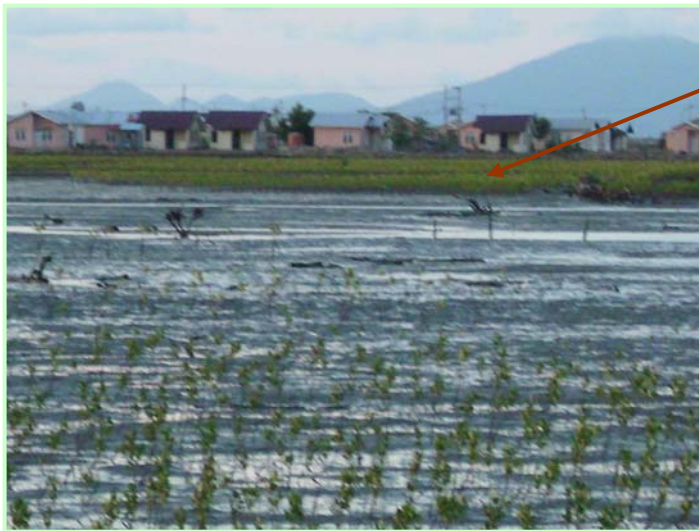
Coming back to specific gaps and problems, The BRR/Forestry Department planting project in Lambaro Skep Village, Kuta Alam District, Banda Aceh was investigated by MAP-Indonesia field staff. The site planted was an aquaculture pond complex with intact cement dike walls surrounded by human settlements. No attempts to restore hydrology were made and hydrology in the area is disturbed by channels, dike walls and community settlements. One million seedlings were planted and, with survivors currently 50cm – 1 meter height. Spacing between plants ranged from 20 cm to 1 meter. Large sections of this planting effort are experience stunting due to sub-optimal hydrology and tight spacing. Local community on-hand during the site visit commented that it would have been better to rehabilitate the shrimp ponds to provide benefits for the community, rather than plant mangroves. This indicates a problem with awareness building and community participation.

BRR – Site at Lambaro Skep Village, Kuta Alam, Banda Aceh. Rhizophora seedlings planted so densely they appear like rice fields.

When planting, either propagules or seedlings, plants should have some reasonable space between them. We recommend 4-8 meter spacing. This enables natural recruits to establish themselves in between planted propagules, promoting biodiversity and allowing for the correct species to be located in the correct space (when mother nature plants them, and they grow, they are in the right place). Planting with appropriate space is also more cost effective, lessens the likelihood of stunting due to competition, allows for small boat and foot traffic, provides future habitat for fish and birds (who like open water), decreases the risk of spread of disease amongst seedlings and decreases the risk of clogging up tidal creeks and channels.

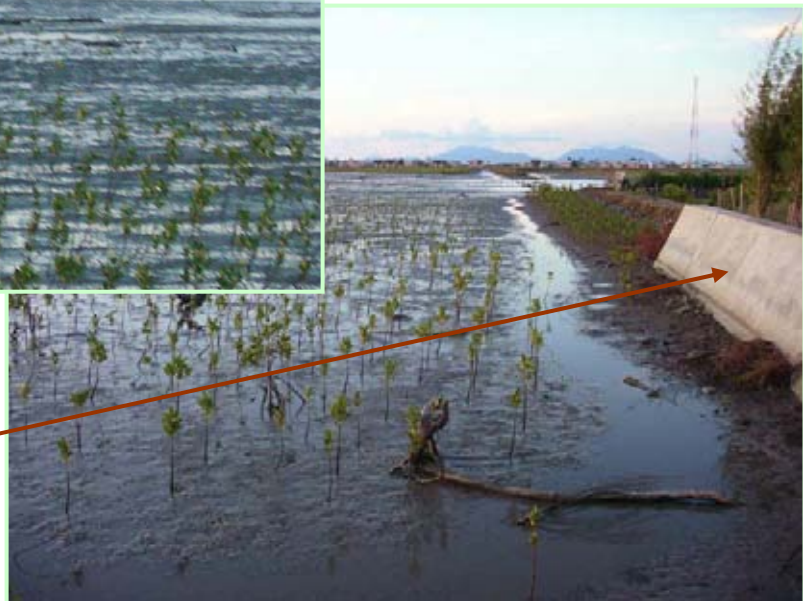
In tact dike walls inhibit natural water flows from land and sea as well as drainage.

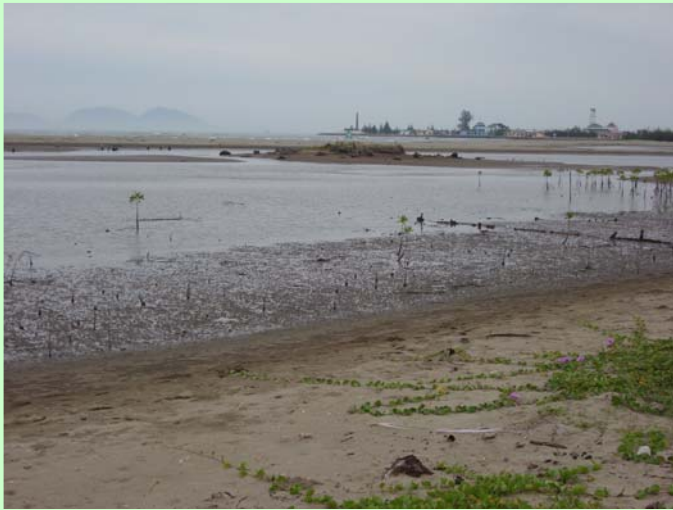
Lamteh, Aceh Besar – A BRR site planted by an independent contractor. This site is experiencing near total mortality in 20 hectares (only 50 trees total surviving). A case of not doing their homework in terms of ecological requirements of the species.

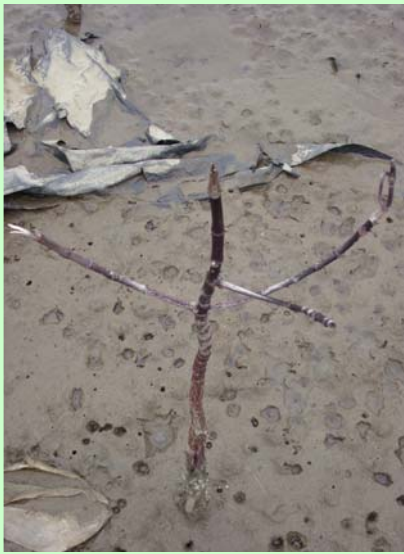
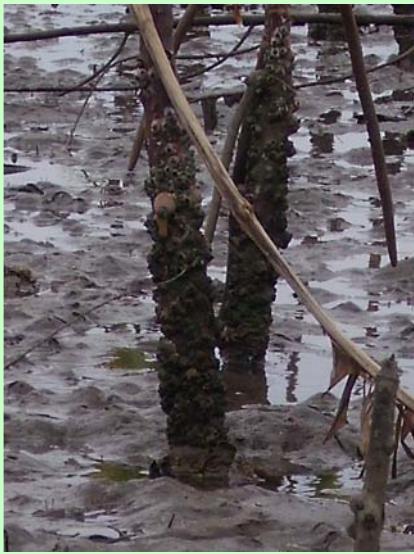
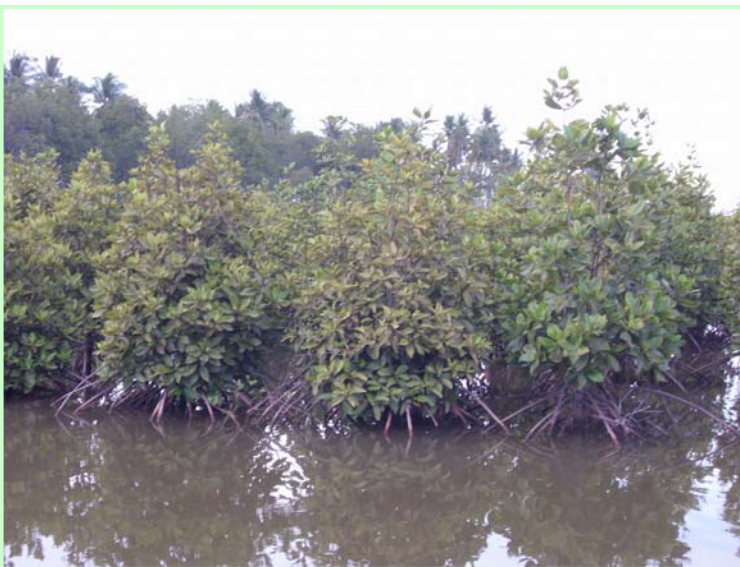
A limited number of Forestry Department plantings are doing well in the same area.
